TEXAS WATER COMMISSION  
WATER RIGHTS AND USES DIVISION  
EVALUATION REPORT

Dam or Reservoir Lake Deerwood Dam  
Owner Lake Deerwood Owners' Association, Inc.  
Stream and Basin Unnamed Tributary of Brushy Creek,  
Cypress Creek Basin  
Adjudication Certificate No. 04-4589  
Application No. 3536 Permit No. 3298  
Authorized Reservoir Capacity at Normal Water Level 240 A.F.  
Inventory No. TX 3582 D/S Hazard [REDACTED]  
General Location 16 miles northwest of Marshall, Texas  
Zone No. 16 County Harrison  
Date of Evaluation October 25, 1988  
Type of Dam Earthfill Structure

LAKE DEERWOOD DAM  
ADJUD. CERTIFICATE 04-4589

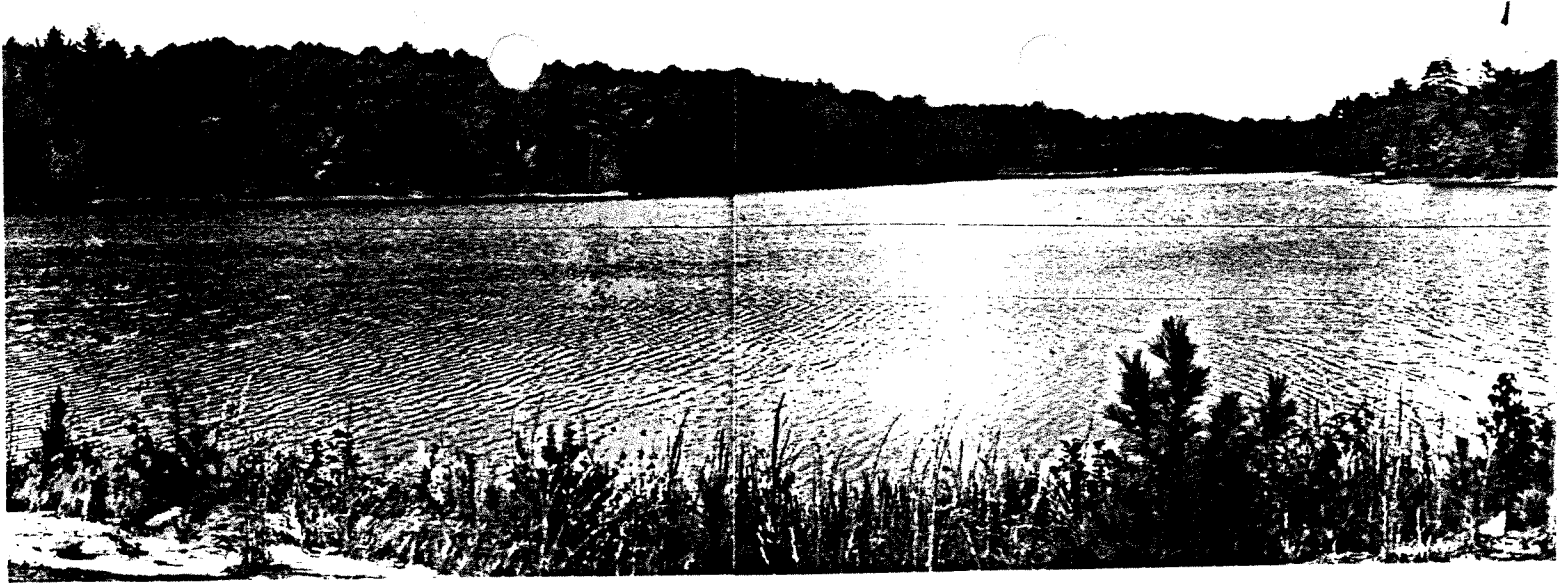
Photo No. 1: Panoramic view of Lake Deerwood from the embankment crest.

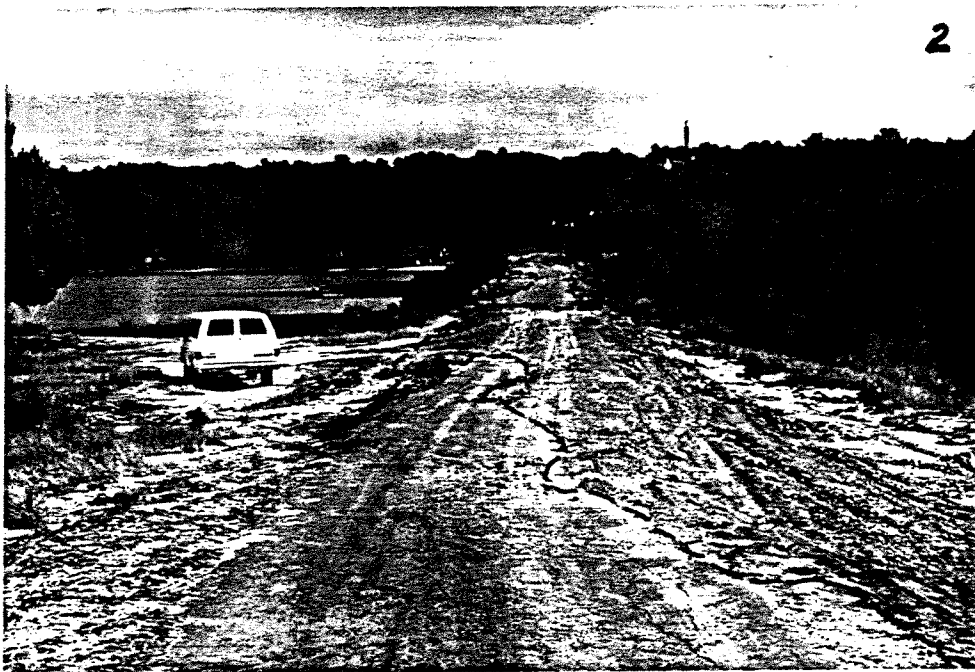
Photo No. 2: Overview of the embankment from a hillside at the right abutment. Repairs have recently been made to the asphalt road that traverses the crest.

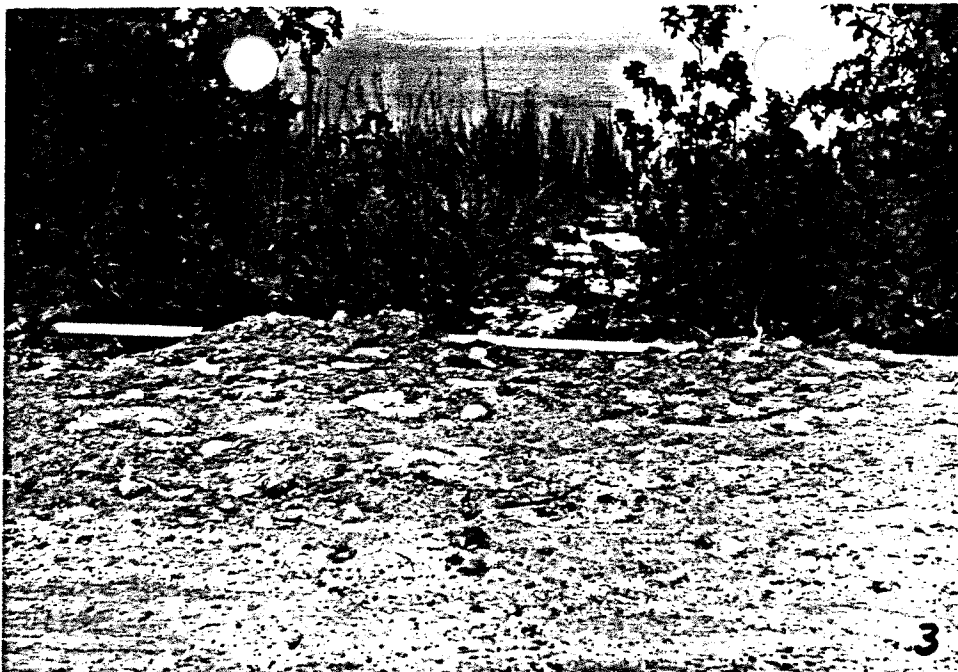
Photo No. 3: This closeup shows a typical repaired area. Loose, uncompacted, sandy loam has been dumped in cuts and irregular areas where the asphalt roadway has deteriorated and become unstable.

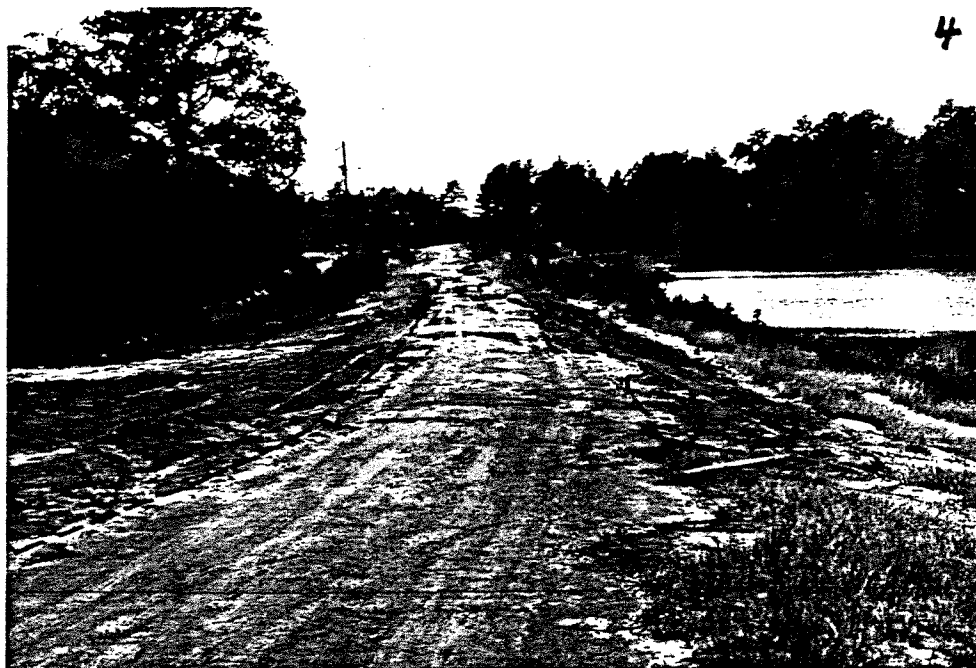
Photo No. 4: Looking back along the 14-foot wide, 1,050-foot long crest from the left abutment. Note the extensive areas that have been repaired. Unless a grass sod is soon established in newly-filled areas, erosion is likely to remove some of the fill.

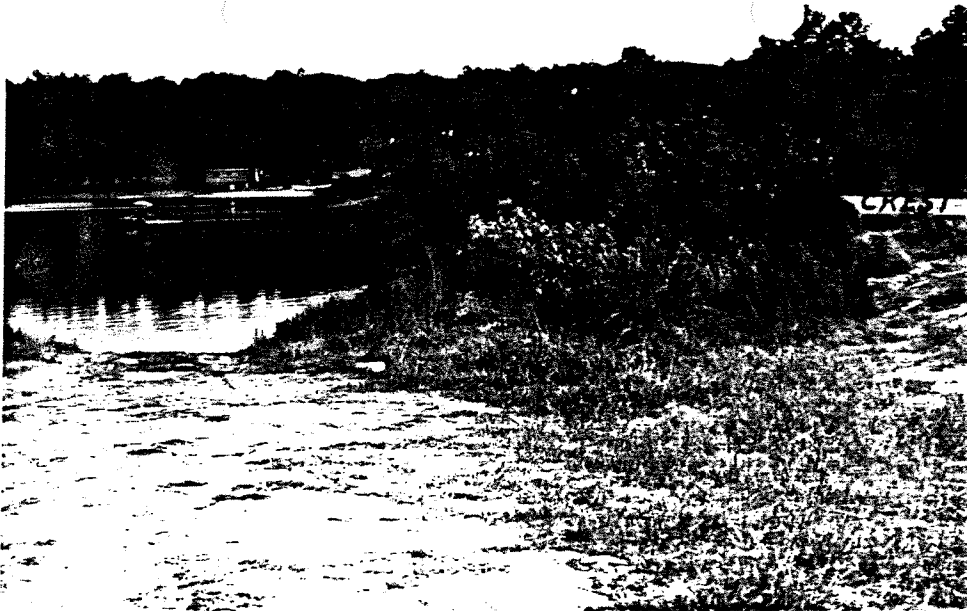
- 1) Brush and small tree growth still exist on both embankment slopes. A comparison with the 1984 evaluation indicates growth has probably not been removed since that date.

Photo No. 5: The 2 1/2 H to 1 V upstream slope. The brush and small trees appear to be regrowth that has increased in size since the 1984 evaluation.

- 1) All brush, and that tree growth having a trunk diameter of four inches or less, should be removed from both embankment slopes to prevent future problems associated with root systems. Care should be taken during removal not to damage the embankment.
- 2) After growth removal from the upstream slope it should be examined for erosion damage. Benched and eroded areas, including cuts, should be repaired/stabilized by appropriate means.
- 3) The stabilization of small gullies at the right embankment/abutment contact is desirable to prevent enlargement due to runoff erosion.
- 4) Seepage along the downstream toe should be kept under surveillance to detect any significant change in pattern or volume.
- 5) The removal of growth for a reasonable distance downstream in the service spillway discharge channel to permit unobstructed flow is desirable.

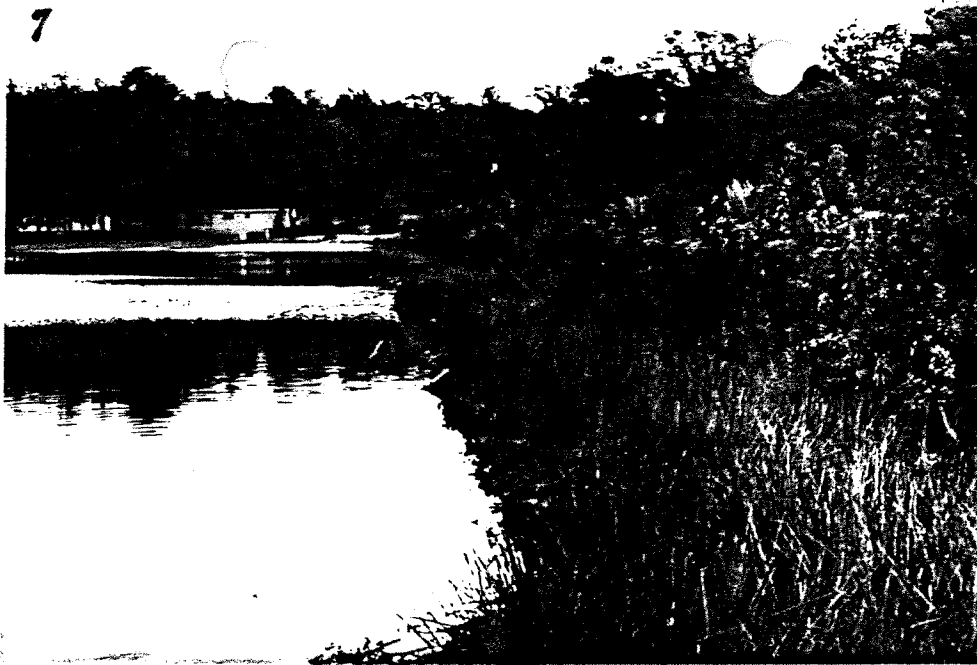
Photo No. 7: That segment of upstream slope is in fairly good condition except for the brush and small tree growth.

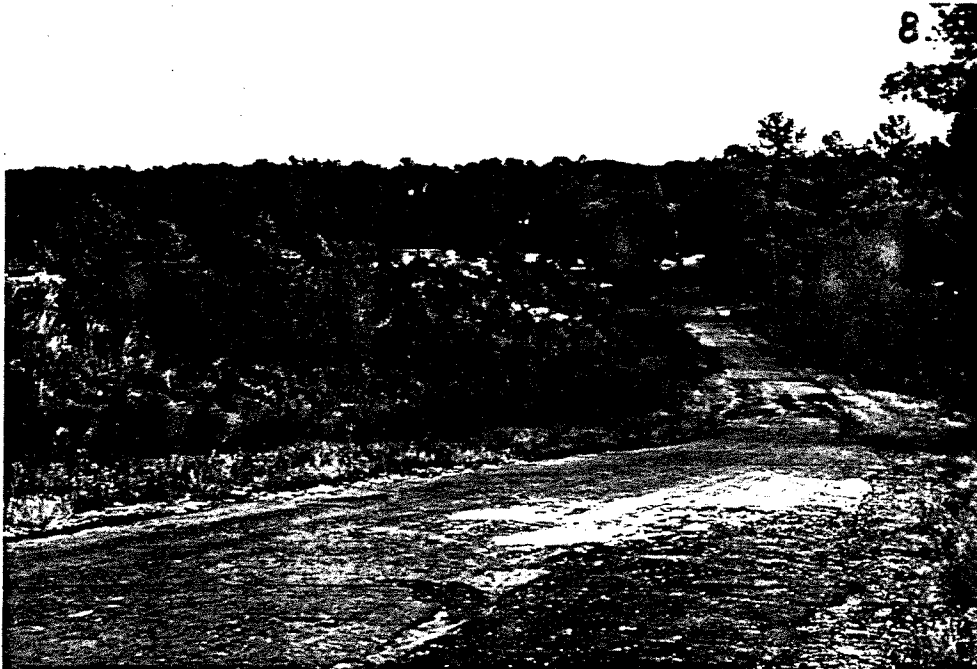
Photo No. 8: Overall view of the 3 H to 1 V downstream slope. Most of the brush and small trees are apparently regrowth from prior cuttings. A cluster of larger trees appears near the right end (foreground).

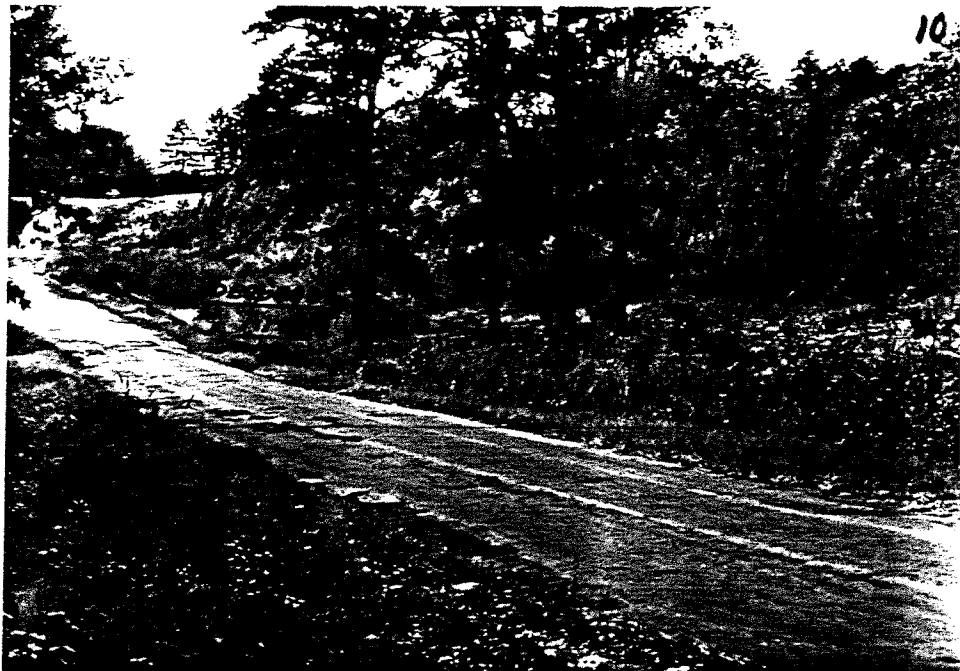
- 4) Seepage is still evident along the downstream toe for a distance of about 200 feet left of the service spillway outlet. Seepage appears to be oozing from the toe along this segment and accumulates in a bar-ditch between the toe and a parallel road. The accumulated seepage exhibits a sluggish movement toward the outlet.

Photo No. 10: The downstream slope as seen from the road near its left end. The dashed line delineates a general area of oozing seepage along the toe.

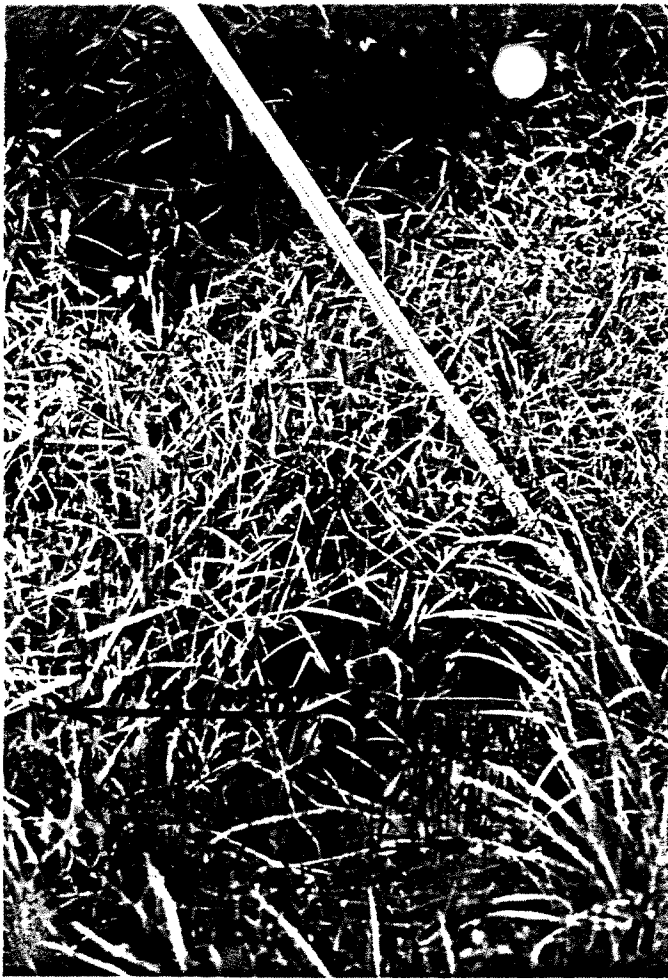
Photo No. 11: This closeup from the road shows an accumulation due to the oozing seepage. The standing to sluggishly-moving water gravitates to the service spillway outlet.

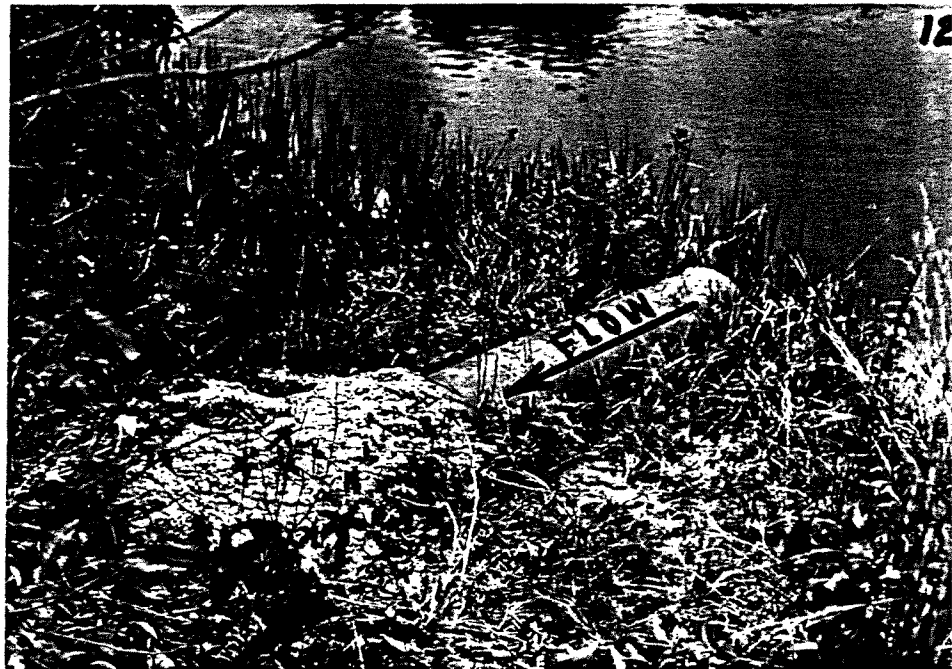
Photo No. 12: The inlet end of the 16-inch I. D., service spillway conduit. This is the only spillway facility for the structure.

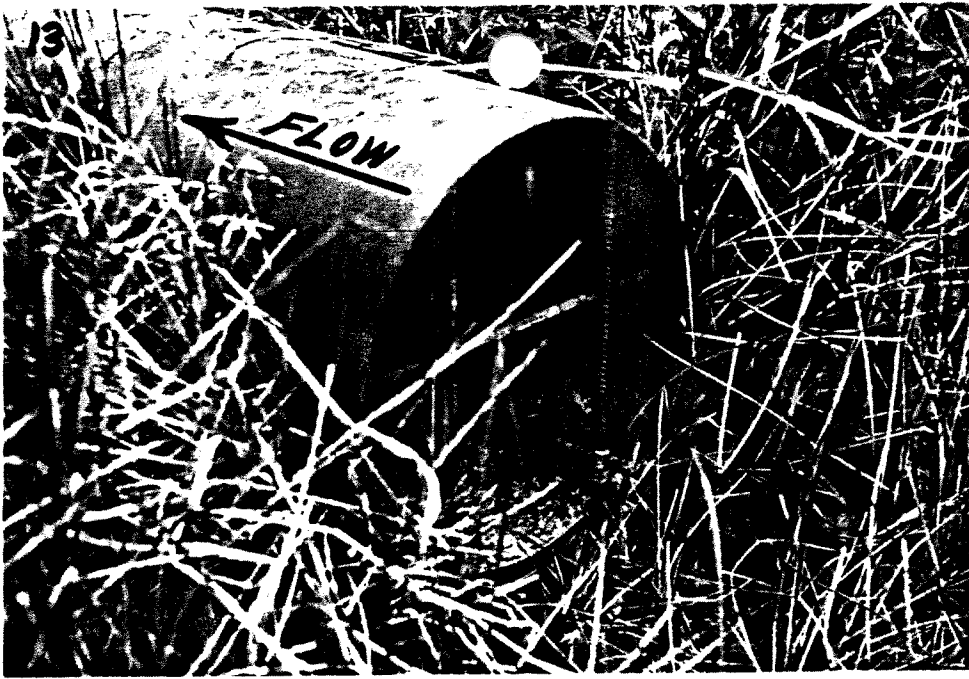
Photo No. 13: A closeup of the service spillway inlet. Note that steel reinforcing rods have been utilized to fashion a large-diameter trashguard.

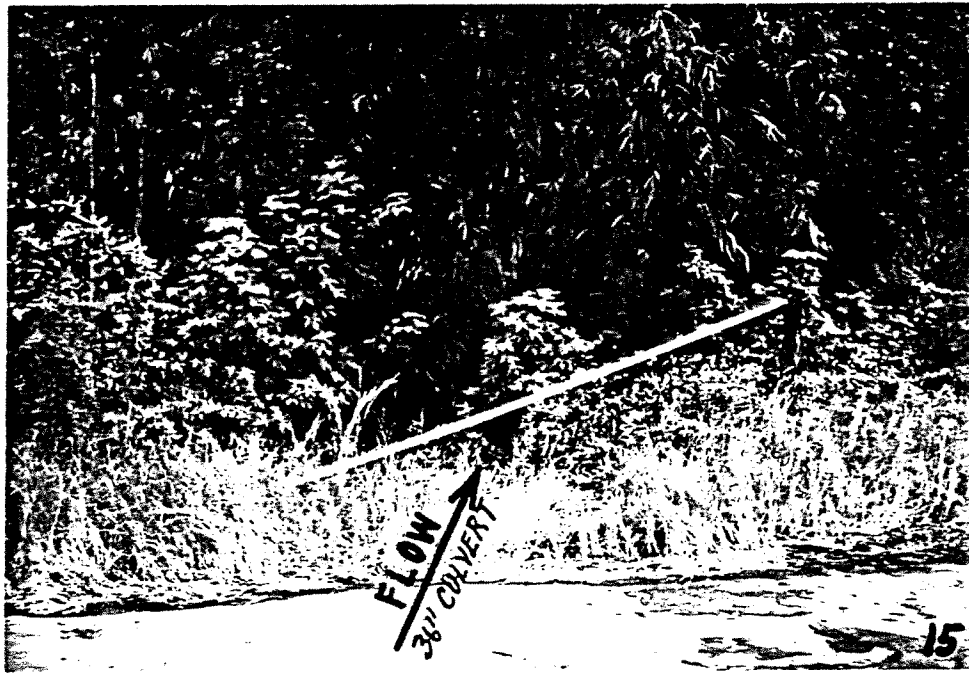
- 5) The discharge channel for the service spillway (i.e. across the roadway) is partially obstructed with a heavy growth of brush, trees, and other vegetation.

Photo No. 15: A downstream view of the service spillway discharge channel from the road that parallels the toe. A 36-inch culvert beneath the road carries discharge from the outlet (previous photo) to this point. Note that the channel is choked with vine, brush, and tree growth.
